Research Article

Case study on the effectiveness of condition monitoring techniques for fault diagnosis of pumps in thermal power plant

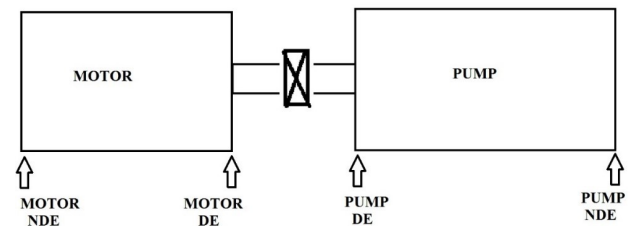
used in ACW pumps was sea water and it was taken by tapping the condenser piping. A bypass was taken from the cooling water pumped by the CW pumps. Vibration readings were taken from points as shown in Figure 1.

Figure 1: Vibration reading points of ACW pump

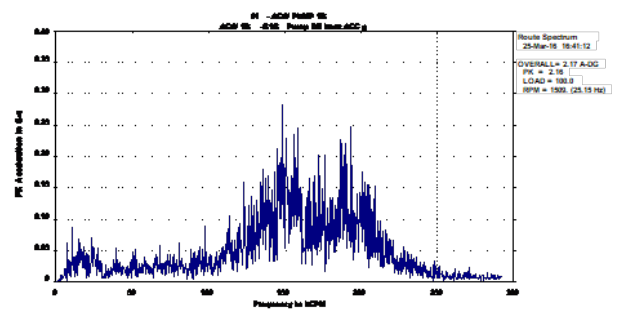
From the readings in Table 1, it can be seen that the acceleration values in pump DE and pump NDE are higher with a rising trend. It was observed that the “g” value was high on pump bearings and the frequencies got excited. The acceleration spectrum of pump DE bearing is shown in Figure 2. These high frequencies happen to be the bearing defect frequencies. Thus, it was suspected that the pump bearing’s deterioration was in progress. Rechecking was done at regular intervals of one hour and it was observed that the pump NDE acceleration value rose to 2.9 g. Abnormal noise was also detected from the pump. The noise readings were taken with acoustic noise meter and it was found to be 130 dB, which is higher than the limits. Ultra-

Figure 2: Acceleration spectrum of pump DE bearing

sonic noise meter was then used to detect the exact location of the noise source and to find the intensity of the flaw. Ultrasonic noise meter detected sounds of continuous hitting over shaft and it showed intensity level of 8 LEDs, which is supposed to be in limits of 5 LEDs. Looseness of bearing or wear ring in the pump was suspected with inference from the observed readings. Since motor vibration readings were well within limits, there was no need of maintenance on motor and electrical side. Mechanical maintenance of the pump had to be carried out.

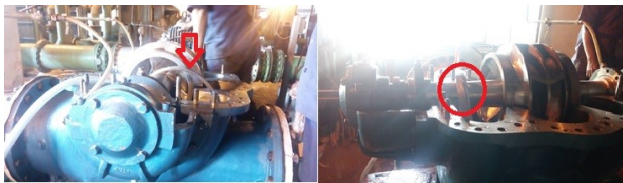
Pump was then decoupled from the motor and the casing cover of the pump was removed. On removal of the cover, the wear ring of the pump NDE end was found to be dislocated from its position. Impeller and shaft were raised from pump casing and wear ring was inspected. The holding screw of wear ring was found to be corroded as shown in Figure 3 and it was replaced. Wear ring was refitted, and the impeller and the shaft were placed back to the casing. Pump bearings were checked for clearance and were found to be fine. Bearings were greased suitably. Pump shaft was then coupled with motor shaft and then checked for alignment using dial indicators. Noise readings were taken using acoustic noise meter and found to be 90 dB and ultrasonic noise meter showed intensity level of 3 LEDs. Motor current signature analysis of motor was carried out and the motor current index was calculated by substituting the values of line frequency and pole pass frequency in Eq. (1). Tongue tester indicated the pole pass frequency of 0.0315 Hz and line frequency of 17.25 Hz. Motor current index was

Figure 3: Dislocated wear ring of ACW pump

After restoring the pump NDE wear ring to its original location, acceleration values were reduced to normal level and no abnormal level sound was noticed from the pump. All the values of vibrations, noise meters and motor current index were found to be in limits. The probable reason of the problem, that is, the pump wear ring being loose, might have created excess load on pump bearing, which resulted in rise of acceleration of pump DE bearing.

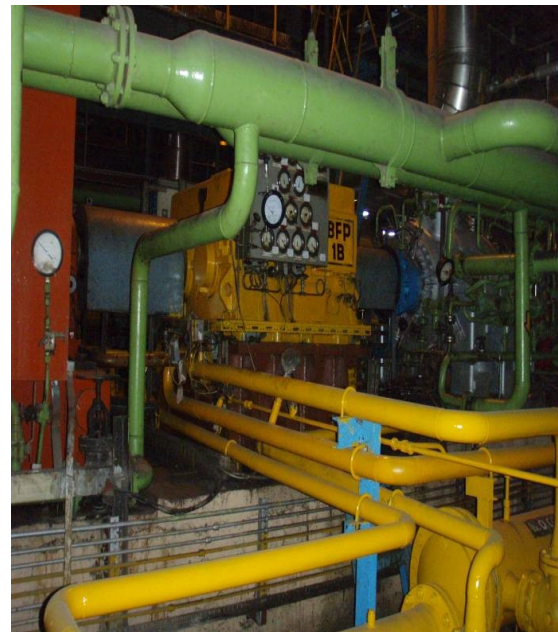
Boiler feed pump is used for pumping the feed water from deaerator to the boiler wall tubes. The water in the deaerator is usually at a very low pressure of 5 kg. BFP requires a suction pressure of 23 kg, and in order to raise the pressure of the feed water in the deaerator, Booster Pumps (BP) are used as shown in Figure 5. The feed water at raised pressure of 23 kg will be then sucked by the BFP and is discharged to the boiler tubes at a pressure of 205 kg. Both BFP and BP are connected to a single motor drive. Motor rotates at a speed of 1500 rpm, which is the required rpm of the BP. So, the motor shaft is directly coupled to the BP. The required speed for the operation of the BFP is 5220 rpm and it is achieved by connecting the shaft of the motor to the BP via step up hydraulic coupling, which steps up the

Figure 5: Boiler feed water pump

speed of the motor (1500 rpm) to the required speed of the BFP (5220 rpm). The main parts of a BFP are pump barrel, rotor, stator and mechanical seal.

Water passes through the suction branch into the intake spiral, and from there, it is directed to the first impeller. After leaving the impeller, it passes through the distributing passages of the diffuser, where it gets certain pressure rise. From there, it flows over guide vanes to the inlet of the next impeller, and from there, to discharge. A small part of the feed water, that is, 10% is taken from the space behind the last impeller for the operation of automatic balancing device to balance the hydraulic axial thrust of the pump rotor. Since the medium of the BFP is hot water, the operating temperature must be maintained in the pumps. Thermal equalizing lines are provided at

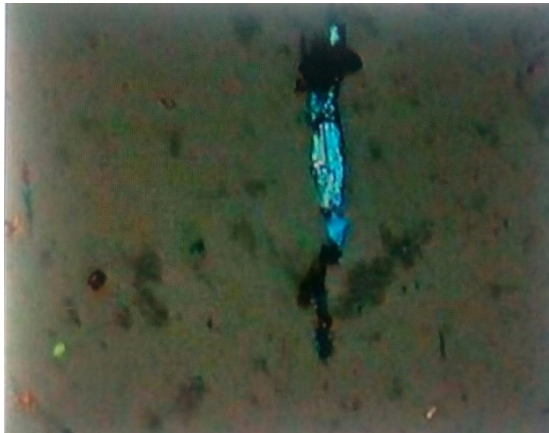
Figure 7: Low alloy steel severe sliding wear particles

- Wear particle concentration (WPC) of the sample is 3.5 WPC (limit is 100).
- Normal rubbing wear particles were observed in small quantities.
- Low alloy steel severe sliding wear particles of the size range of 24 microns were observed in negligible quantities, as shown in Figure 7.
- Spheres were observed in small quantities.
- Sand/dirt particles were observed in small quantities.

Wear debris analysis of the oil in the hydraulic coupling is done by collecting the oil sample from the hydraulic coupling oil bypass with the help of a vacuum pump. Ferrography is carried out on the collected sample of oil and the results of the tests are discussed below. The wear debris analysis of the oil sample showed the following results:

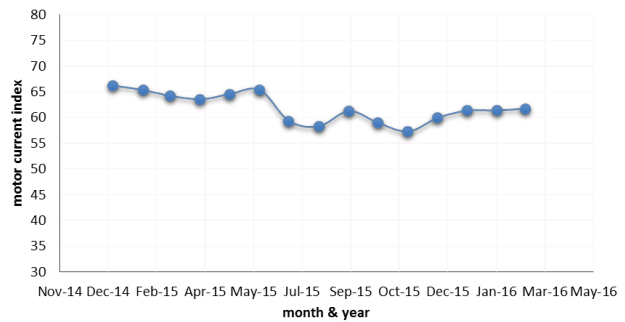
Figure 8: MCI trend of BPW pump

Motor current signature analysis of motor was carried out and the motor current index was calculated to be 61.72 dB, when the line frequency was found to be 15.9 and pole pass frequency was found to be 0.0125. The trend of MCI for a period of two years is shown in Figure 8. Noise monitoring of the boiler feed water pump was measured using an acoustic noise meter (110dB) and an ultrasonic noise meter (3–5 LEDs). The noise reading and the MCI index values were found to be well within limits.

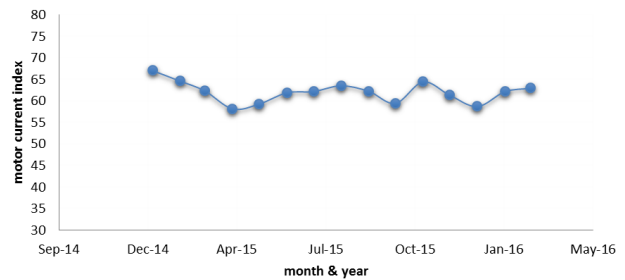
**Figure 10:** MCI trend of Condensate Extraction Pump

Motor current signature analysis of motor was carried out and the motor current index was calculated to be 60.8 dB when the line frequency was found to be 23.24 and pole pass frequency was found to be 0.021. The trend of MCI for a period of two years is shown in Figure 10. Noise levels of the boiler feed water pump was measured using an acous-

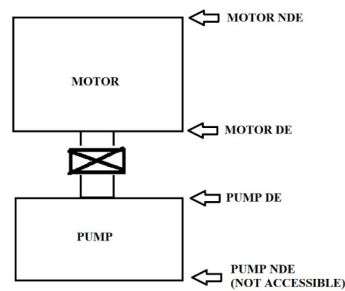
Condensate extraction pumps are used to draw the condensate from the condenser hot well and feed it to the deaerator through low pressure heaters. It is a vertical double entry canister pump and it is provided with 5 impellers as shown in Figure 9. The liquid is sucked at a pressure of 0.5 bar and it is passed through the five stages of the impeller to produce a discharge pressure of 22 bar. Vibration readings of the condensate extraction pump were taken and were found to be within limits as shown in Table 3.

**Figure 9:** Condensate Extraction Pump
